# Collapse of the World Trade Center Towers

Written by G Charles Clifton,  
HERA Structural Engineer

17<sup>th</sup> September 2001 and revised 19<sup>th</sup> September.

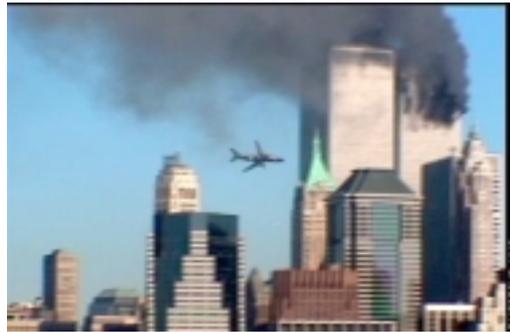
Each tower was hit by a Boeing 767. The impact on the North tower was near the center of the North face at around the 95<sup>th</sup> storey, with the plane hitting the side of the building square on and flying level. The impact on the South tower was some 15 storeys lower, with the plane hitting the South face near the South East corner and impacting at an angle to the face of the tower. Fig 2 shows the impact directions and Fig 8 shows the plane about to hit the South Tower.

Fig. 8  
Plane About to Hit South Tower  
(Photo from CNN)

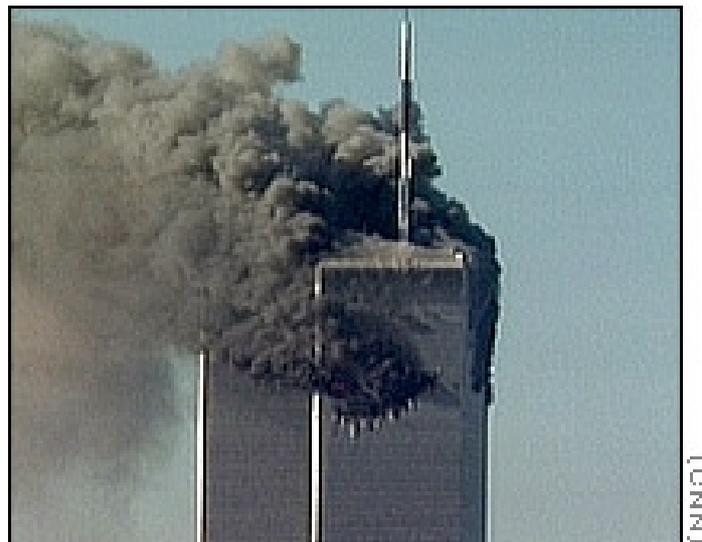
Fig. 9  
North Tower After Impact Viewed From the Impact Side  
(Photo from CNN)

Fig 9 shows the view looking into the impact hole. Given that the floor slabs are at 3.66 m centers and the façade column centers are at 1.03 metre centers with façade window widths of only 0.48 m, the number of façade columns and perimeter beams severed by the airplane in its passage through the perimeter frame is considerable. From the major damage to the side opposite the impact it is also apparent that much of the airplane would have passed through the core. It is likely that the impact destroyed most of the floors, at least on the impact side, and the core on at least three levels, removing many of the core supporting columns, at least on the North side of the core, and leaving the remainder buckled and stripped of their passive fire protection. This would have caused the floors above the impact level to sag

downwards in the center, with the gravity columns above the impact region now acting as tension ties between each of the upper floors, through to the top floor. Each upper floor would now have had to be at least partially supported off the perimeter frame. HERA has developed a method (based on UK fire research) allowing the design of unprotected secondary beams in composite floor systems by using the dependable inelastic reserve of strength from a region of floor slab supported around its perimeter. I have applied this in a very approximate manner to a typical WTC floor slab supported off only the perimeter frame and the result shows that this is just about possible with regard to the membrane capacity of the floor system, but not possible in terms of the vertical load carrying capacity of the connection between the floors and the perimeter frame. As the vertical load carrying capacity of the core diminished, requiring more load to be transferred from the floors to the perimeter frames, the mode of failure would have most likely been failure of this connection, leading to floor collapse.

1. If the temperatures inside large regions of the building were in the order of 700+ deg C, then these regions would have been glowing red hot and there would have been visible signs of this from the outside. Also there would have been visible signs of flames. If one looks at the photos of the Cardington fire tests, the flames and glowing of the steelwork is clearly visible even in the large enclosure test where the maximum fire temperature was only 700 Deg C. In contrast, the pictures of the towers after the collapse and prior to the impact show sign of severe burning over only relatively small regions of the tops of the towers, even pictures taken from the air looking horizontally into the impact region (eg Fig.9).

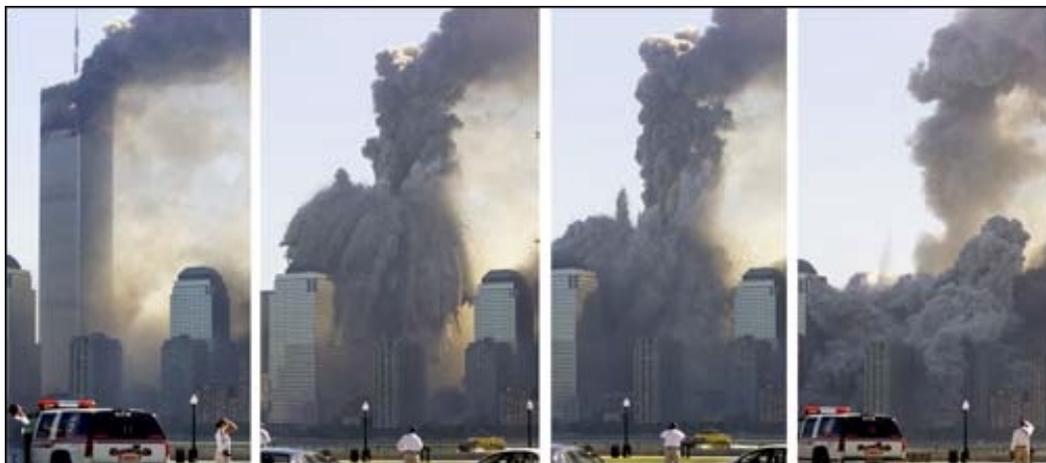
Finally, it is likely that the interconnection between one or more floors and the perimeter frame failed at or near the top of the building. This would have resulted in the immediate collapse of these floors. From the video footage this collapse appeared to occur uniformly around the building and spread very rapidly down to the floor above the impact region. That region then pancaked causing a brief gout of flame to be expelled most noticeably from around the South and East sides as the areas within the impact region still on fire collapsed.

The collapse then continued down the building, with the floors pancaking leaving the perimeter frames briefly standing unsupported until they too collapsed. The effect of the floors pancaking nearly straight down inside the perimeter frames lead to the North tower effectively imploding, with some sections of the perimeter frame remaining standing unsupported for a few seconds before collapsing. This is seen from a number of video footages and pictures, including the collapse sequence shown in Fig 10.

Fig. 10  
Sequence of Collapse of North Tower  
( Photo from CNN)

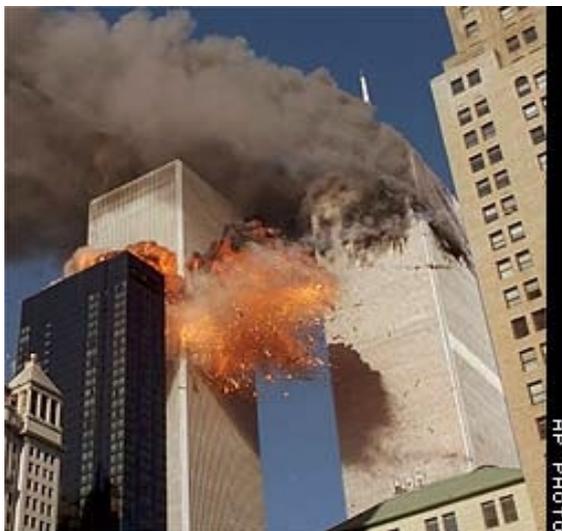
At 9.03 am the plane impacted the South side of the south tower towards the South East corner. It struck the building at an angle across that corner and on a slight downwards heading, as shown in Fig.2. The plane passed into the building and then exploded out of the adjacent East side, causing a large fireball to erupt from both the entry and exit sides adjacent to the South East corner. Fig. 8 shows the plane immediately before impact and Fig 11 shows the expanding fireball erupting from both sides of the building.

In contrast to the North Tower impact, in the case of the South Tower only one corner of the core would have been directly in front of the plane's path through the building, along with the floor slabs over several levels in the South East corner. It is likely that the initial impact destroyed all the floor slabs in that corner over at least four levels and maybe over as many as six. It would have also severely damaged the South East corner core, removing an unknown number of columns there, buckling many more and destroying most of the

Fig.11  
Fireball From Impact on South Tower  
(Associated Press photo)

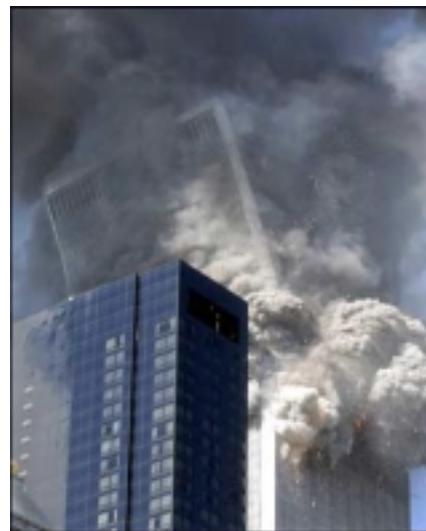
Fig.12  
Top of South Tower Collapsing  
(Photo from CNN)

Finally the combination of increasing compression load on these damaged columns, with second order effects from this load acting on the buckled shape of these columns over their unsupported length, would have caused their collapse. This collapse would have initiated in the damaged corner and spread rapidly over the impact region, causing the tower above to fail by toppling sideways with the floors above the impact region momentarily in an intact condition. This stage of the collapse is shown in Fig. 12.
