# Collapse of the World Trade Center Towers

Written by G Charles Clifton,  
HERA Structural Engineer

17<sup>th</sup> September 2001 and revised 19<sup>th</sup> September.

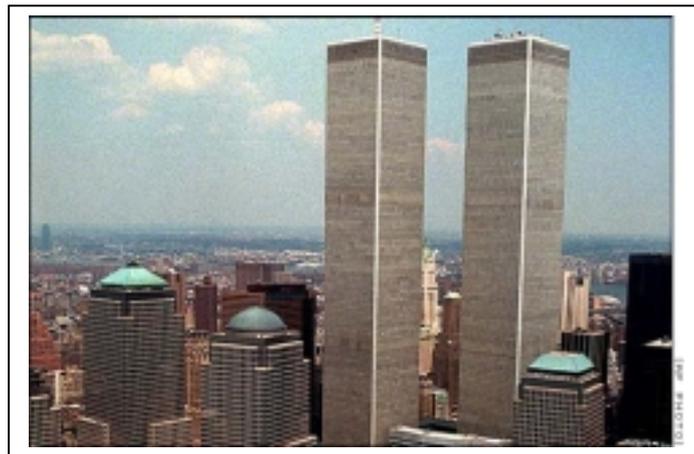
Fig 1  
World Trade Center Towers Before Attack  
(Associated Press photo)

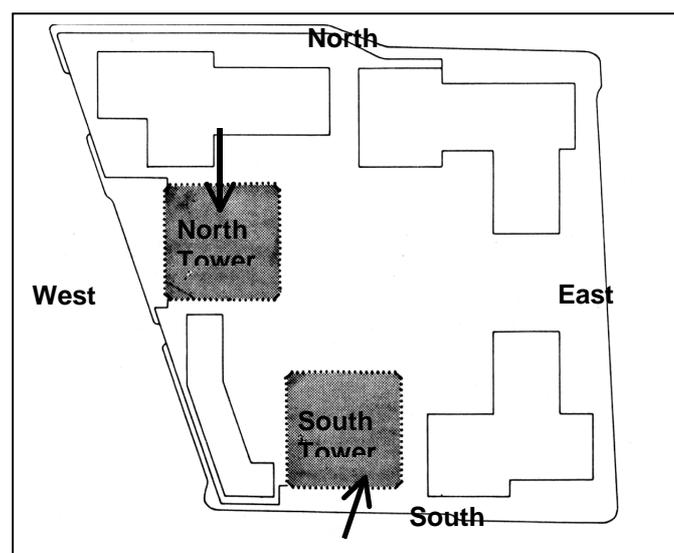
Fig. 2  
Site Plan of World Trade Center Development Showing Location of the  
Two Towers

(The direction of arrows adjacent to each tower shows the approximate direction of the planes on impact)

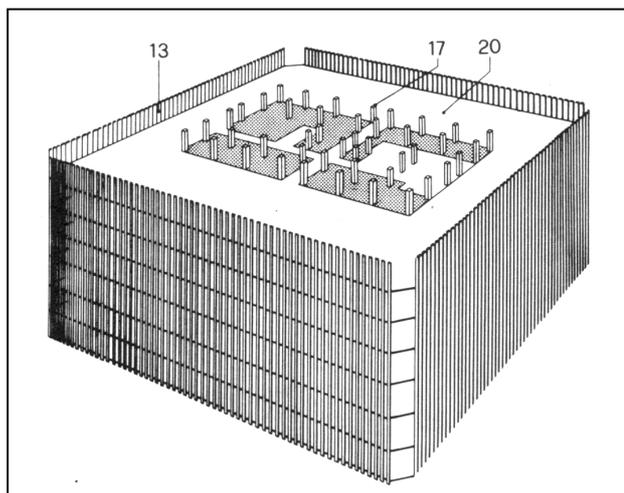
**Fig. 3**  
Isometric View of Building  
(from [1])

The numbers in the figure are taken from [1] and denote:  
13 – Perimeter frame  
17 – Core box columns 450 mm square  
20 – Floor slab

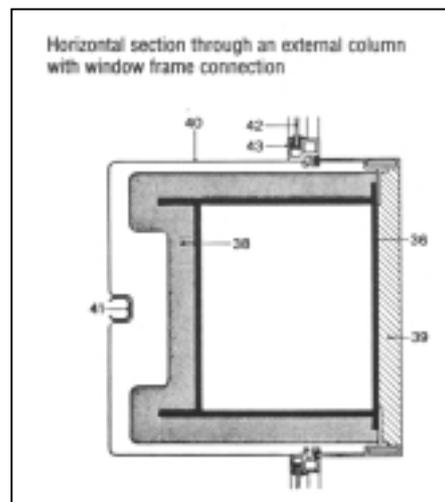
**Fig. 4**  
Cross Section Through  
Exterior Box Column (from [1])

The numbers in the figure are taken from [1] and denote:  
36 – Steel column  
38, 39 – Fire resistant plaster  
40 – Aluminium façade  
42 – Window glass  
43 – Window frame
